## ACQUISITION RESEARCH CASE SERIES

**Mark XIV Torpedo Case Study**

**26 February 2011**

**David F. Matthews, Senior Lecturer**

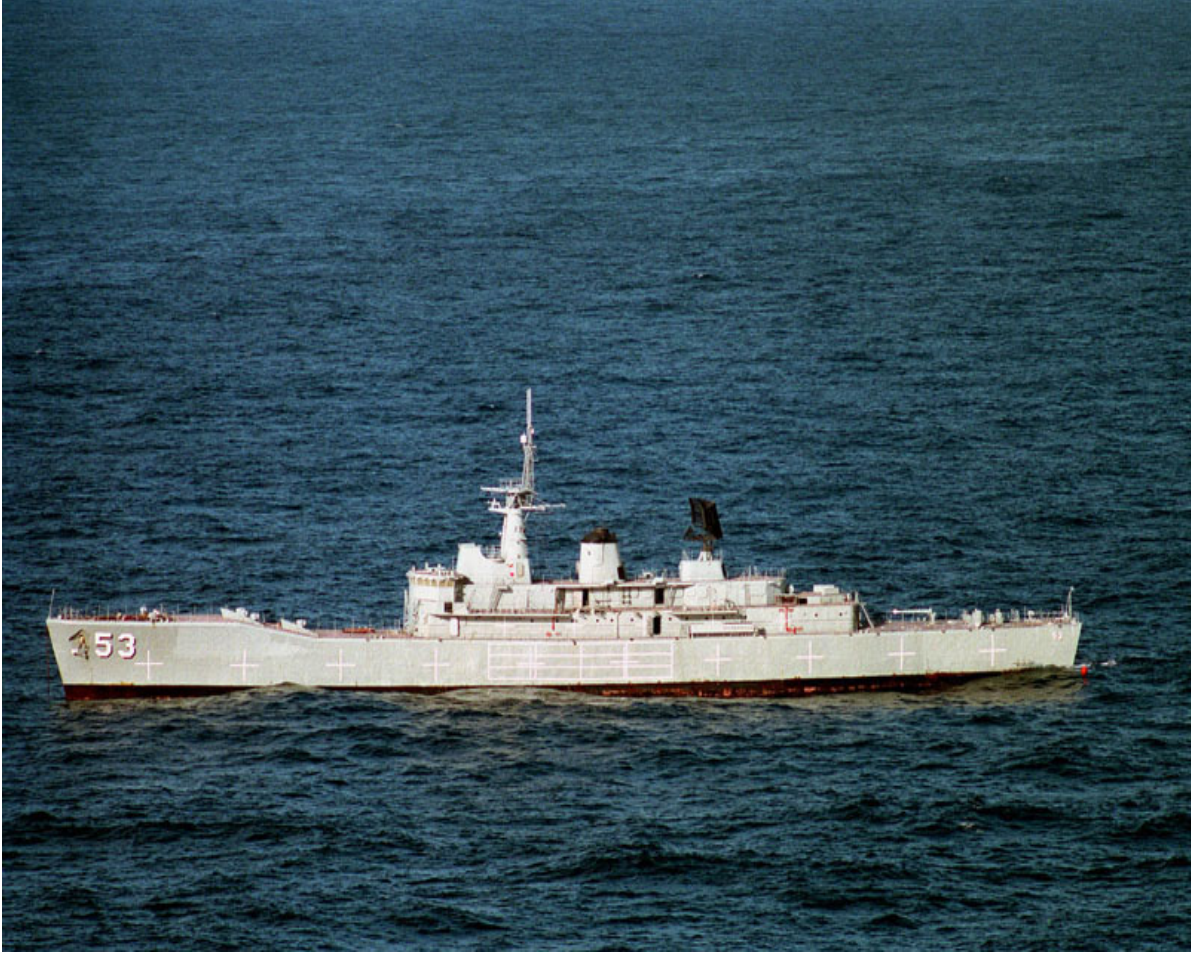
**Figure 2. Destroyer Prior to Detonation**  
(Navy Undersea Warfare Center, 1999)

Figure 2 is a picture of the obsolete full-sized Australian destroyer that served as the test target. Everything useful was removed from the destroyer—all turrets, depth charges, secondary armament, etc. The configuration is visible in subsequent photos. Figure 2 shows the target ship sitting dead in the water waiting to be engaged.

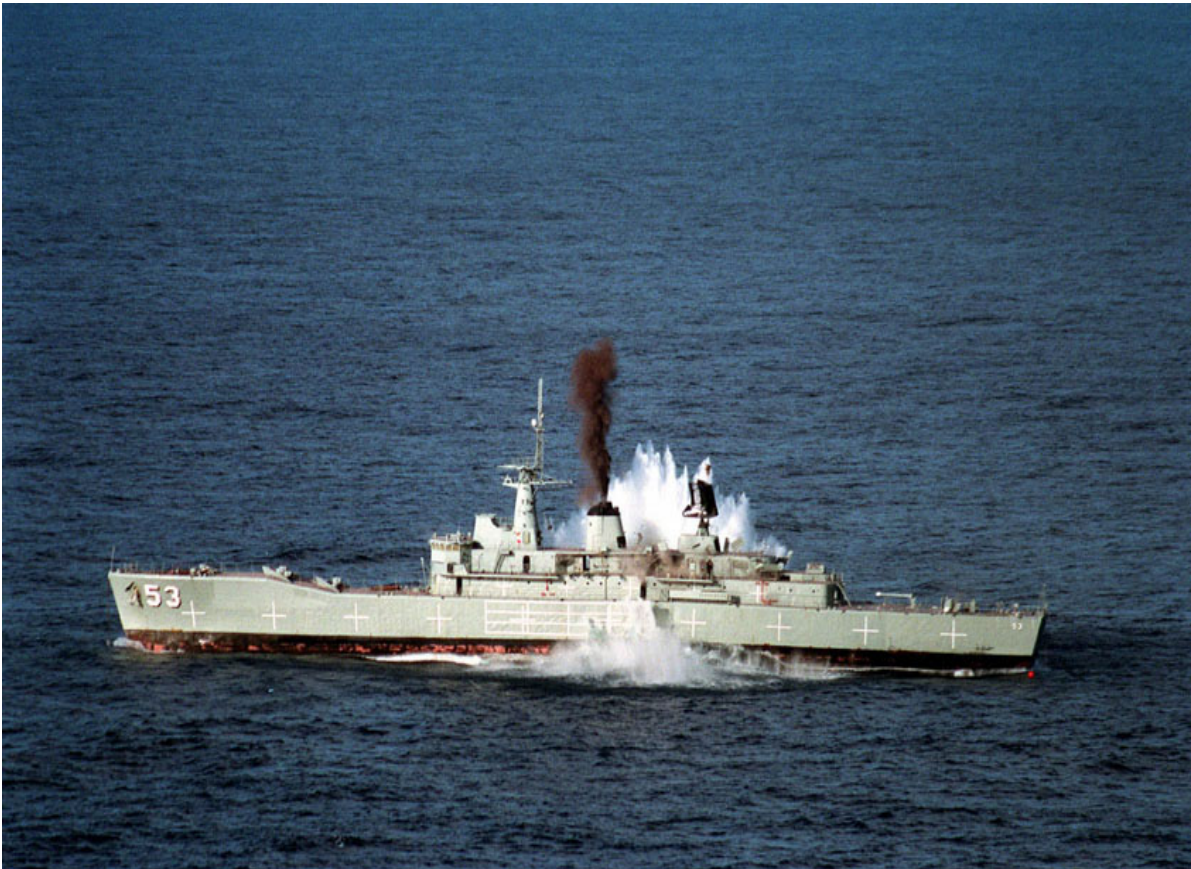
**Figure 3. Initial Reaction**  
(Navy Undersea Warfare Center, 1999)

Figure 3 is a photograph of the moment the torpedo was detonated. The photograph shows that smoke has been blown out of the stack because of the power of the explosion, and it shows that water is starting to erupt on either side of the ship. In Figure 3, the ship already appears to have had its keel broken because the bow and the stern are lower than the center of the ship.

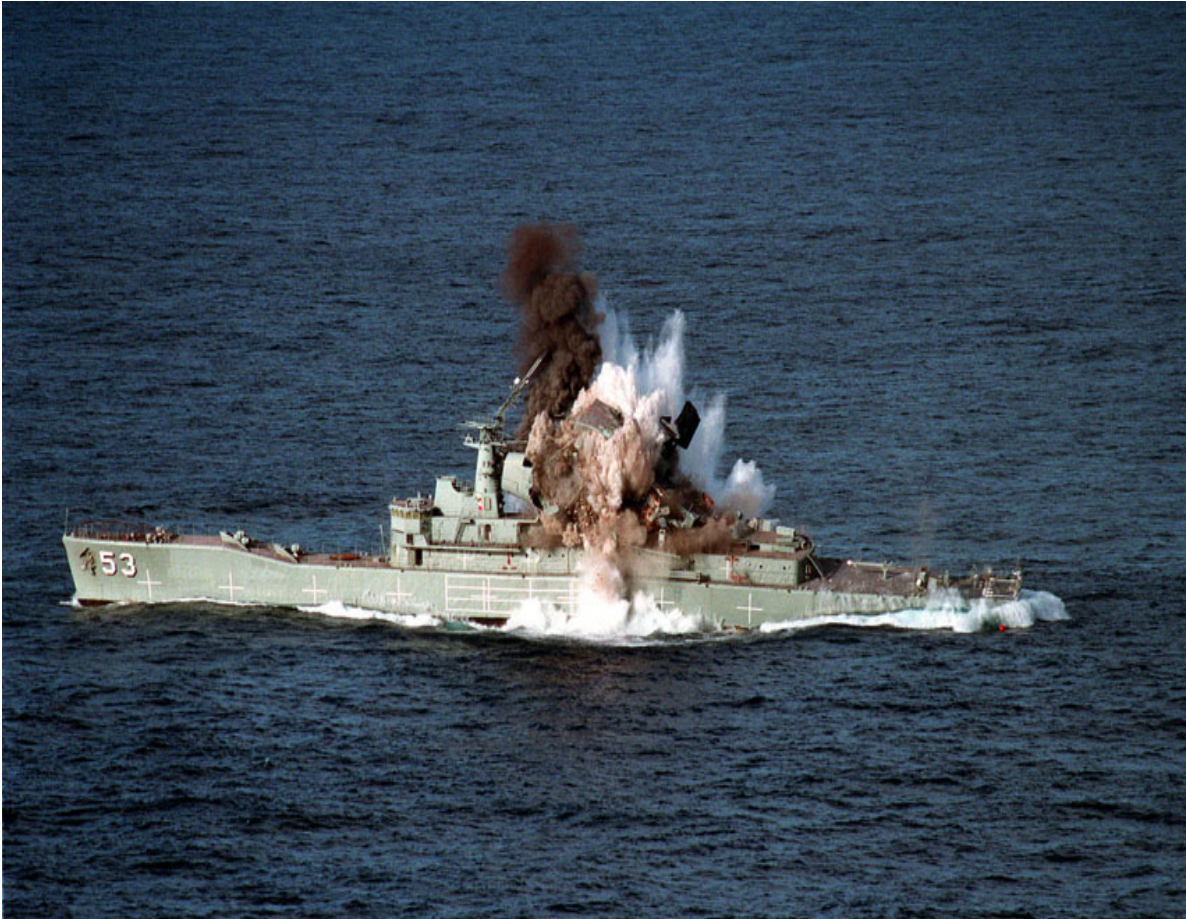
**Figure 4. Further Damage**  
(Navy Undersea Warfare Center, 1999)

Figure 4 is a photograph of a few seconds, maybe even milliseconds, later. The explosion has propagated even further, and the power of the torpedo warhead's explosive is visible as it goes straight up through the bowels of the ship along the center line—and it only gets worse.

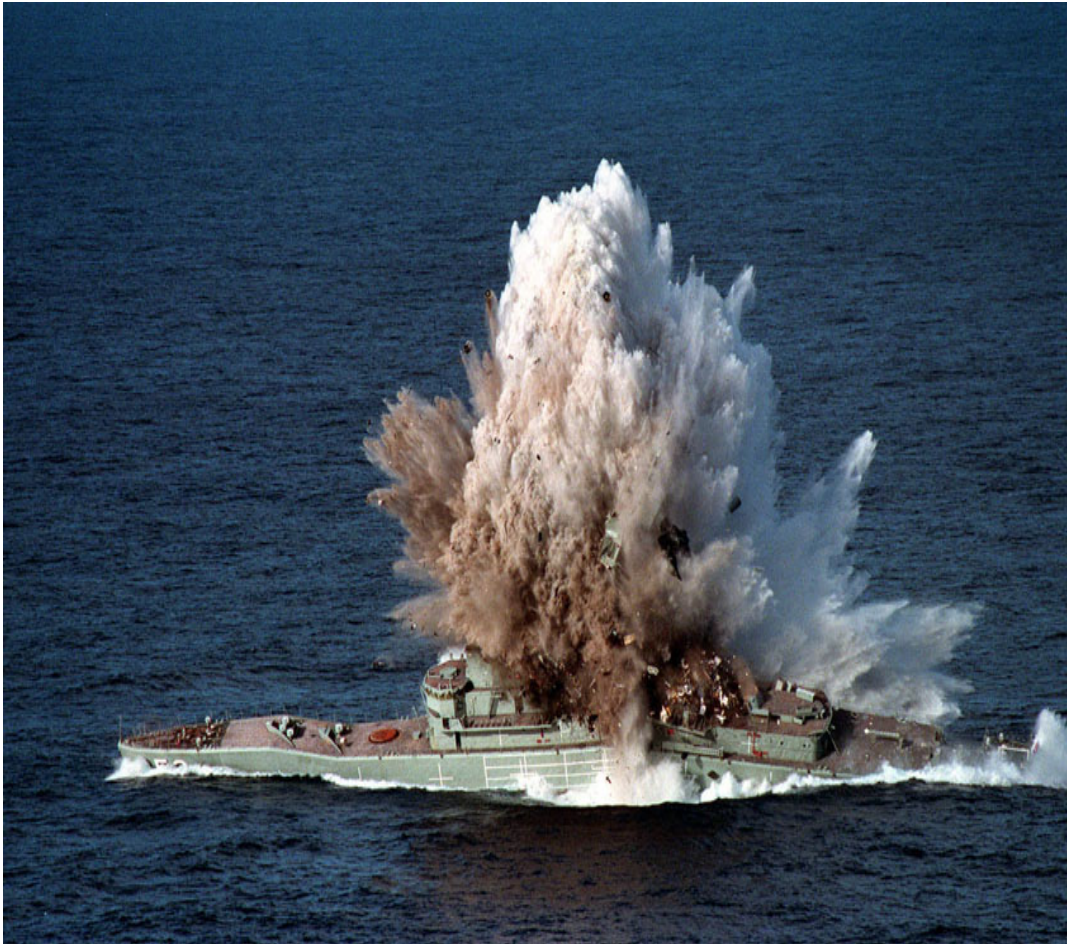
**Figure 5. The Keel Has Broken**  
(Navy Undersea Warfare Center, 1999)

Figure 5 clearly shows that the back of the destroyer has been broken. The extensive level of damage that is taking place is obvious.

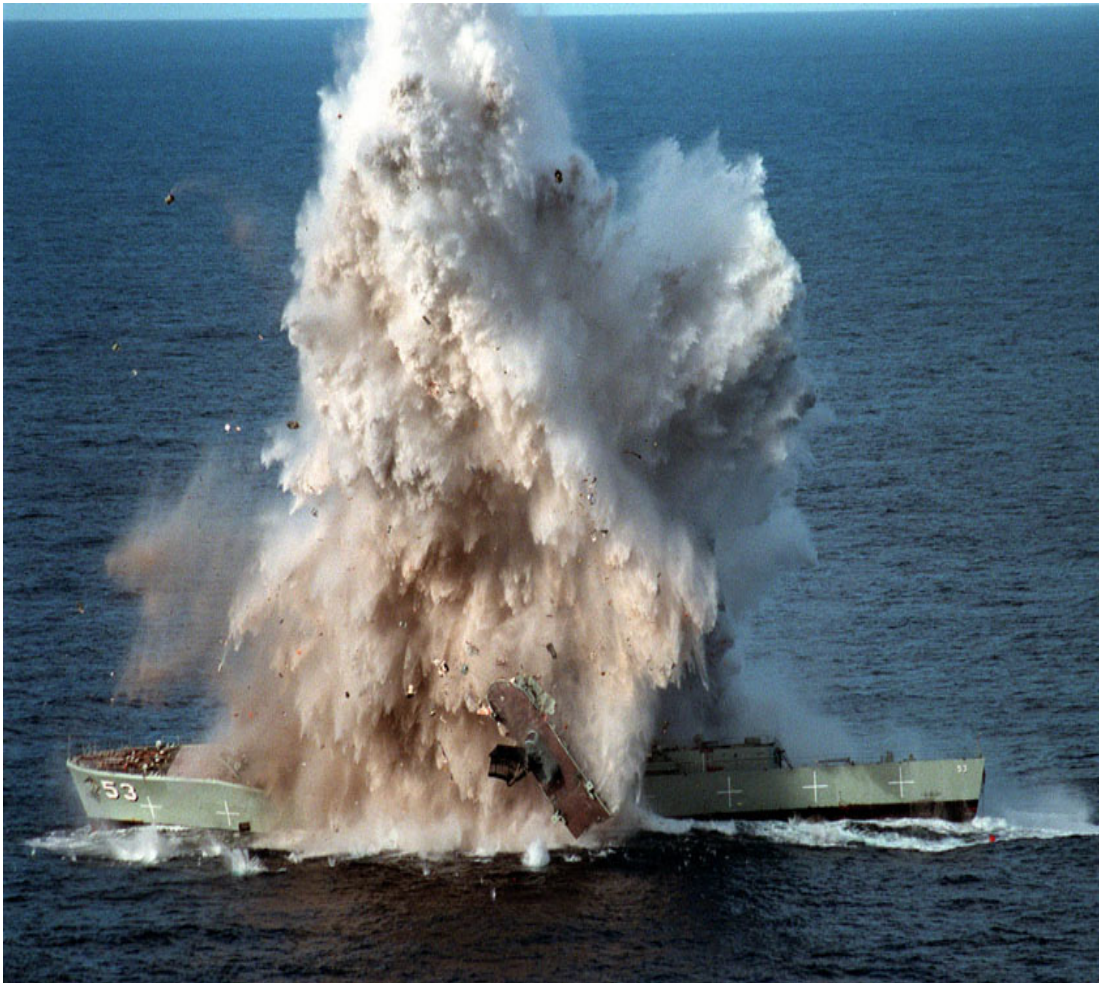
**Figure 6. Bow and Stern Sections Separate**  
(Navy Undersea Warfare Center, 1999)

Figure 6 shows that the level of damage is now catastrophic.

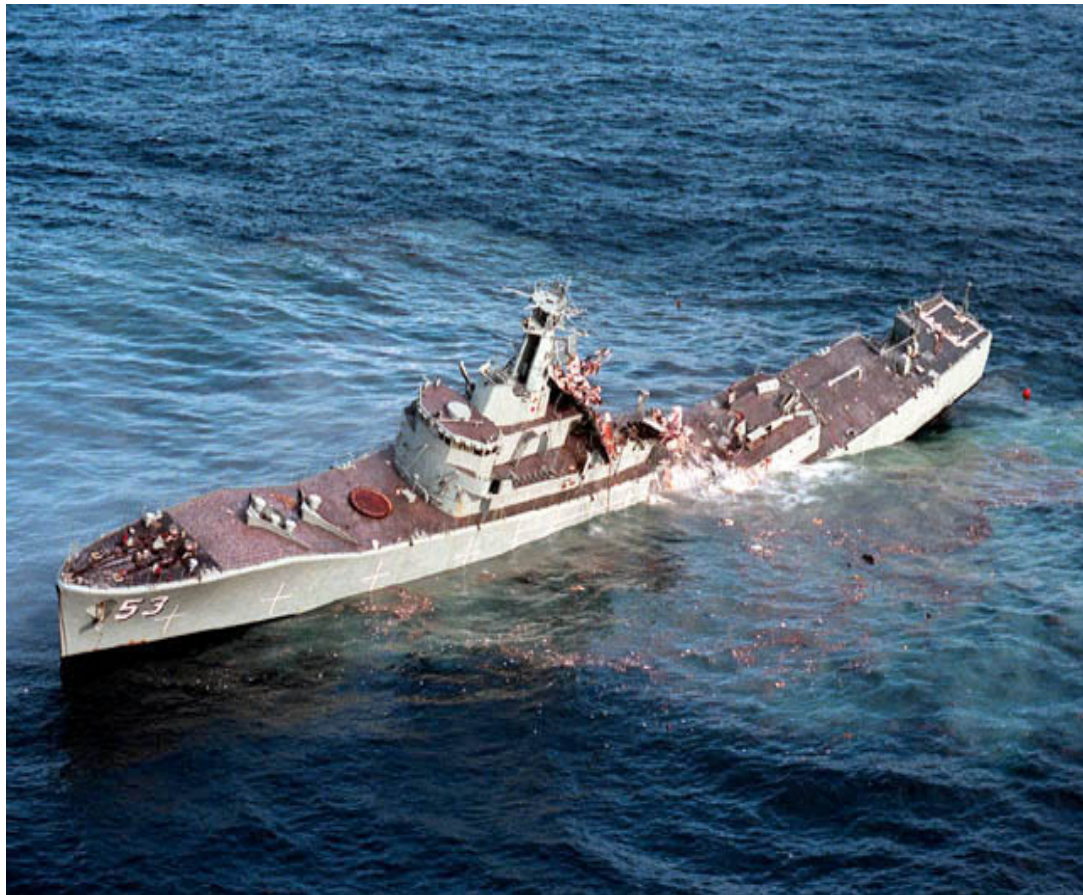
**Figure 7. The Stern Begins to Sink**  
(Navy Undersea Warfare Center, 1999)

As the smoke clears in the photograph in Figure 7, it is clear that the destroyer has broken into two halves and that the stern section is about to sink.

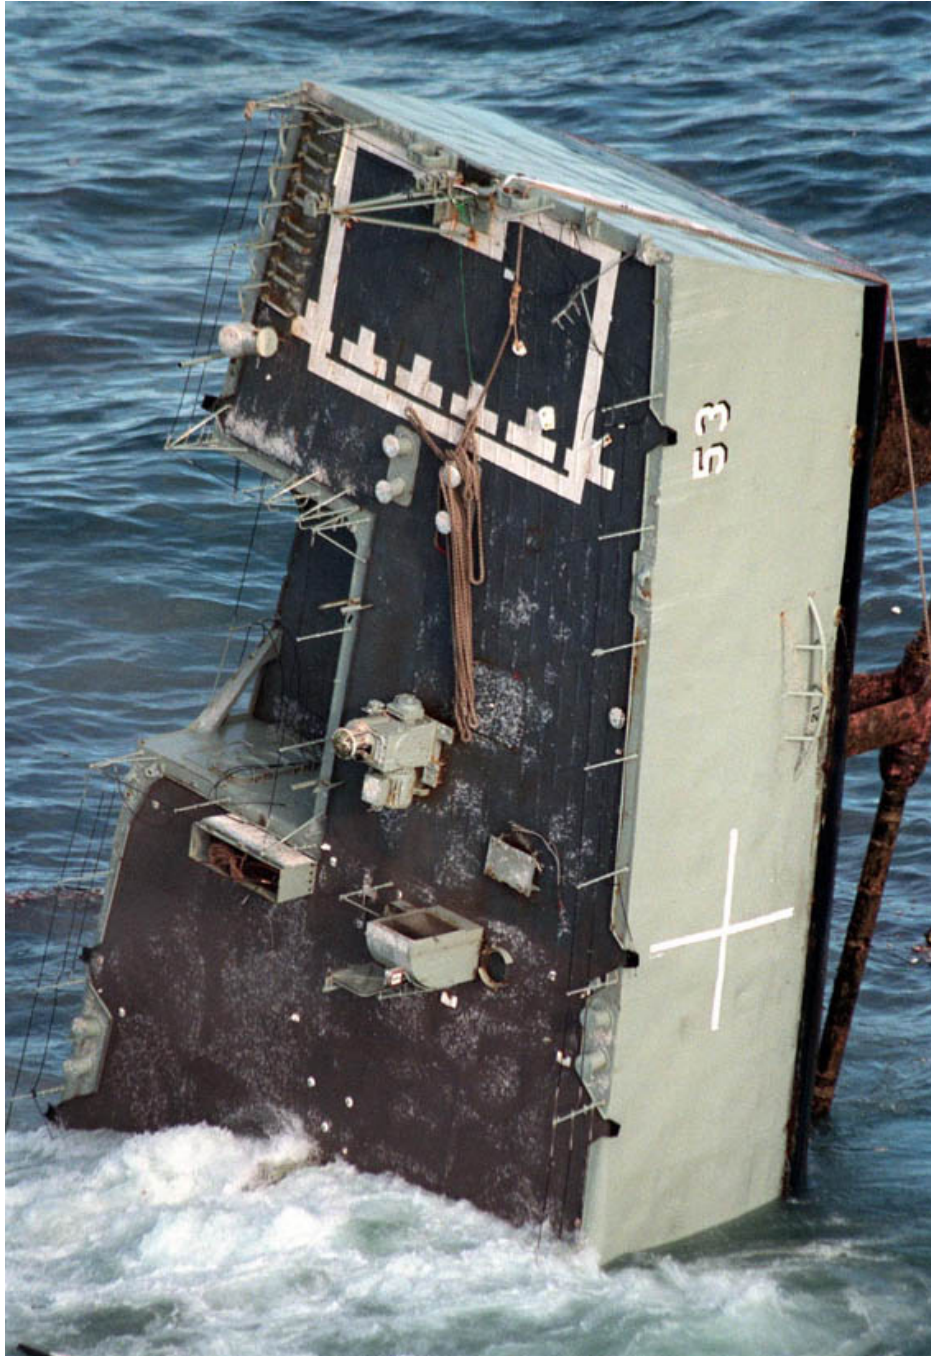
**Figure 8. The Stern Slips Under the Waves**  
(Navy Undersea Warfare Center, 1999)

Figure 8 shows that the observation made in Figure 7 is accurate: the stern section is headed to “Davey Jones’ Locker.” The photograph in Figure 8 is a close-up of the destroyer as it slips beneath the waves.

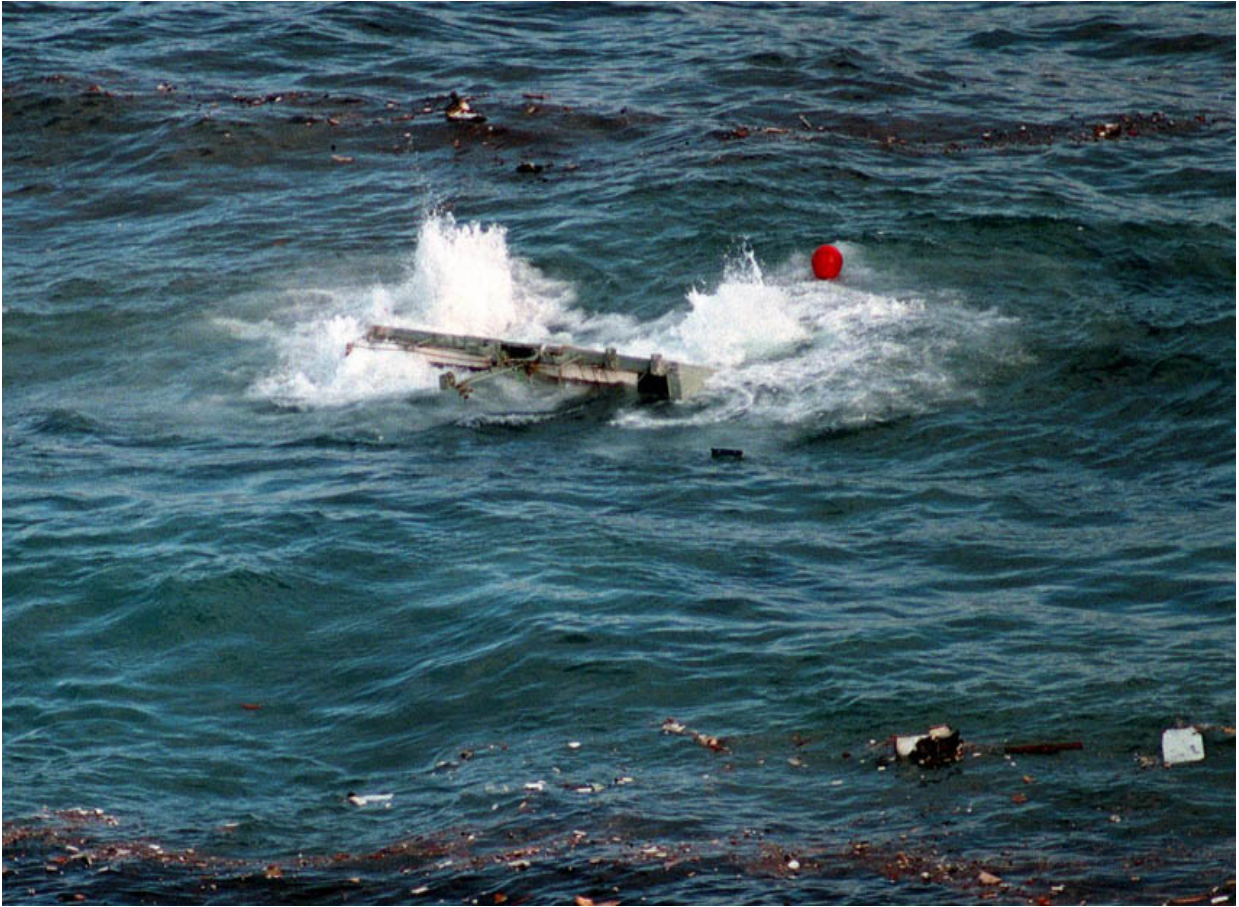
**Figure 9. The Stern Disappears**  
(Navy Undersea Warfare Center, 1999)

Figure 9 is a close-up photograph of the residual debris field.

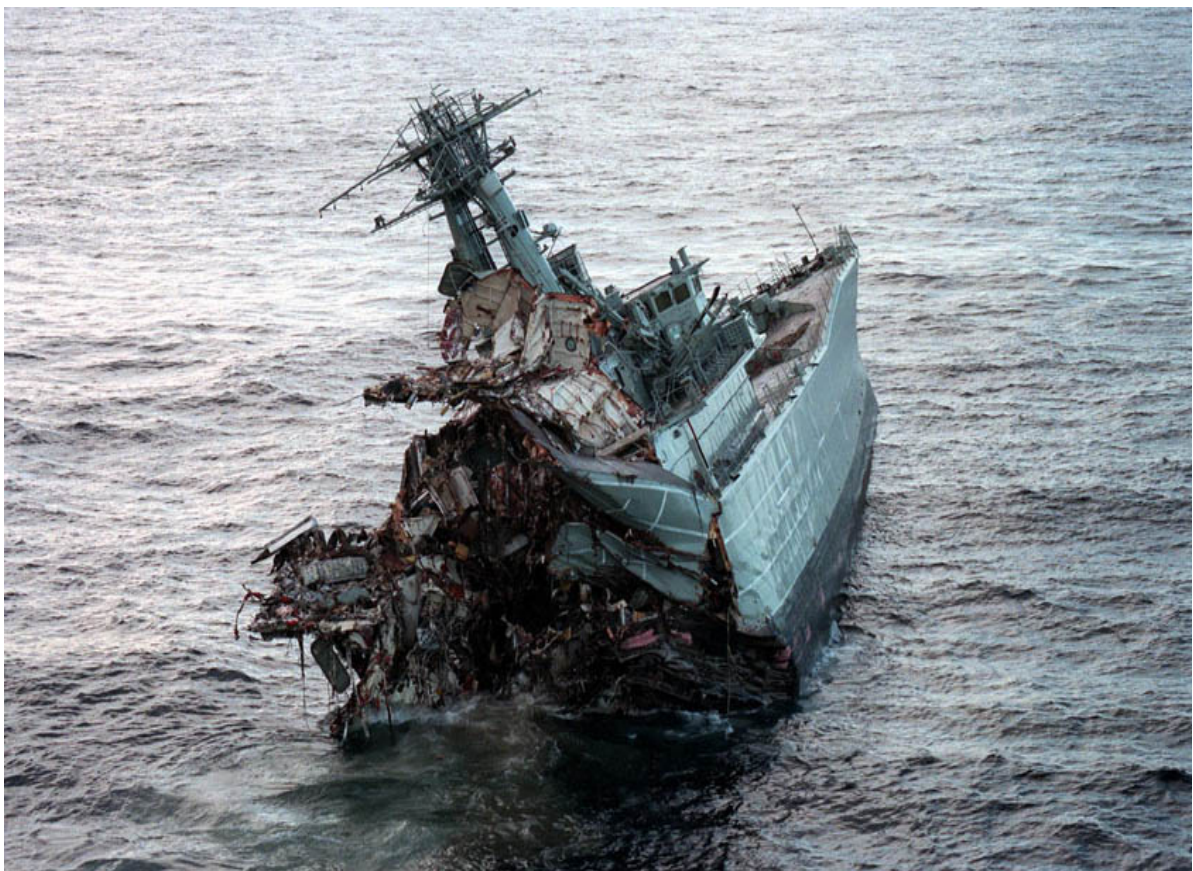
**Figure 10. The Residual Bow Section**  
(Navy Undersea Warfare Center, 1999)

Figure 10 is a photograph of the bow section of the ship. As the photograph shows, it is not economically repairable. The damage is so bad that by the time the Australian Navy would have tried to salvage what is left there in order to rebuild a new ship around it, it would have been better to have started from scratch. Plus, ship designs evolve, and if this were an older ship, it would probably be better from a cost-effectiveness standpoint to acquire a “latest and greatest” warship of a similar class to replace this one. In this test, the bow section actually sank a few hours after the photograph in Figure 10 was taken.
